# David Rittenhouse

## Telescopic Theodolite

>> By Jeffrey D. Lock

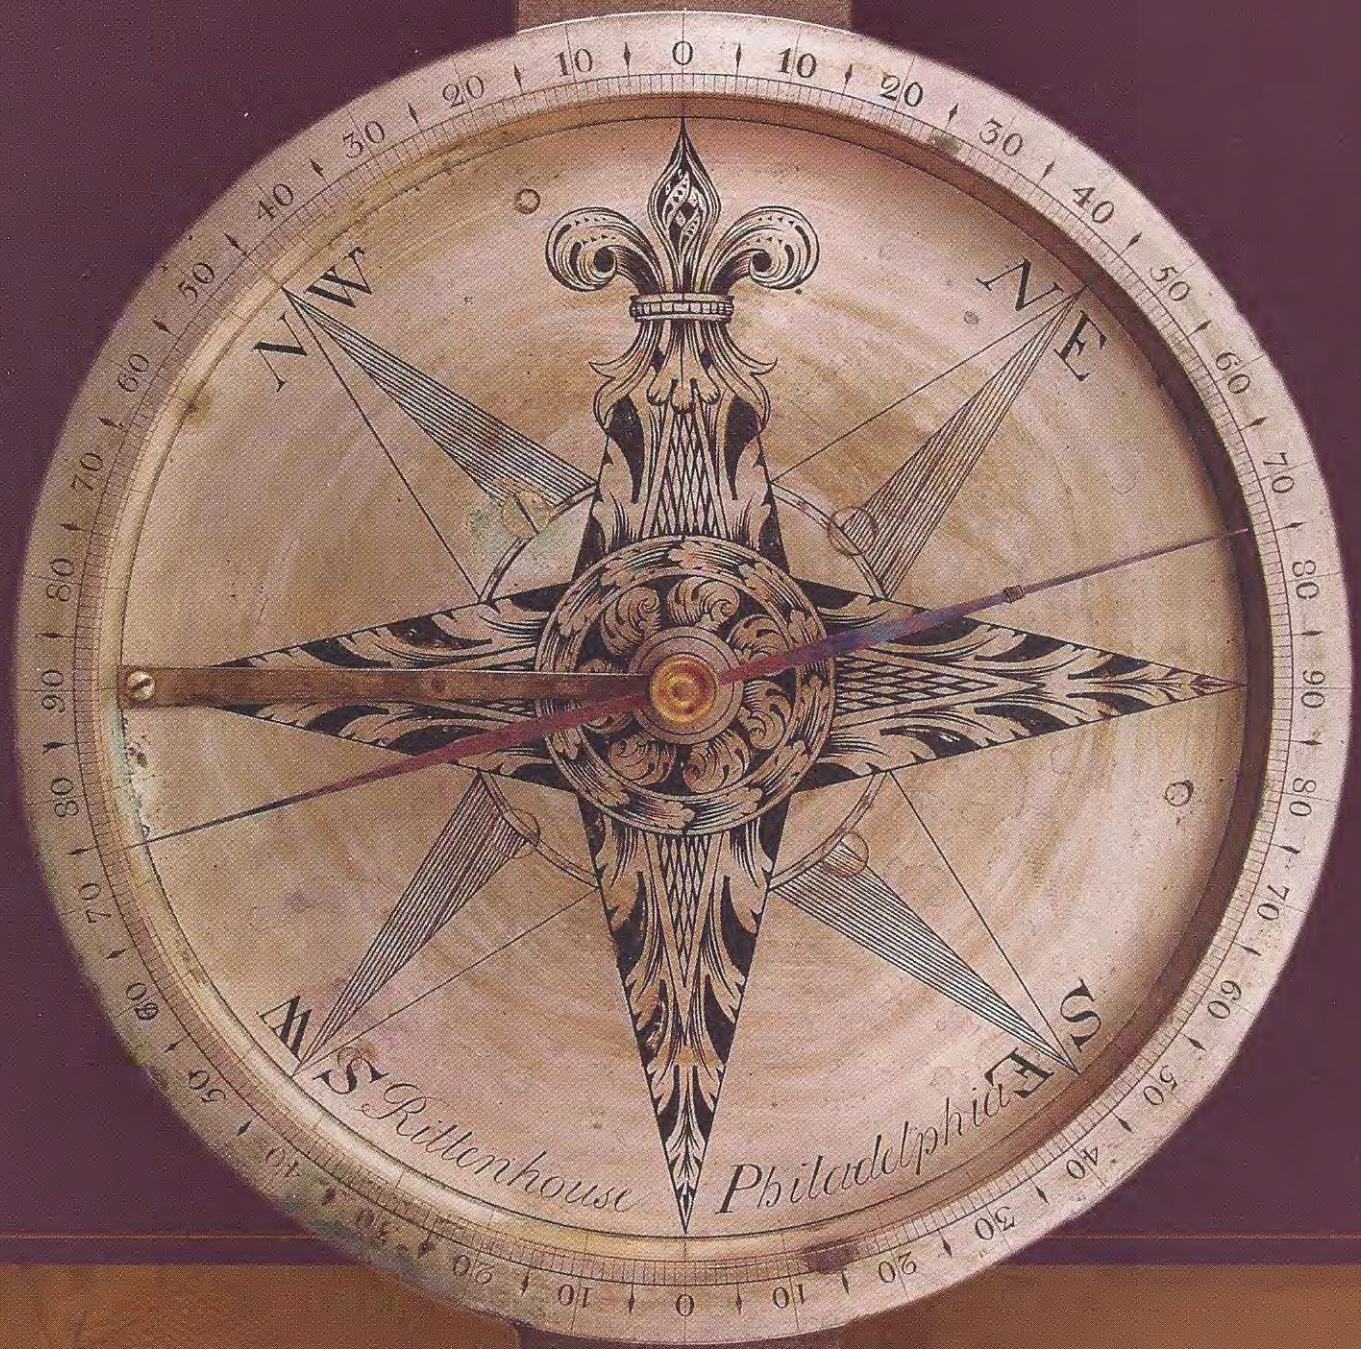
Figure 1

ends of the main arms cut off in a most unceremonious manner. How could one do this to such an artistic instrument? To make matters more disconcerting, the instrument was signed, "Rittenhouse, Philadelphia." (Figure 1)

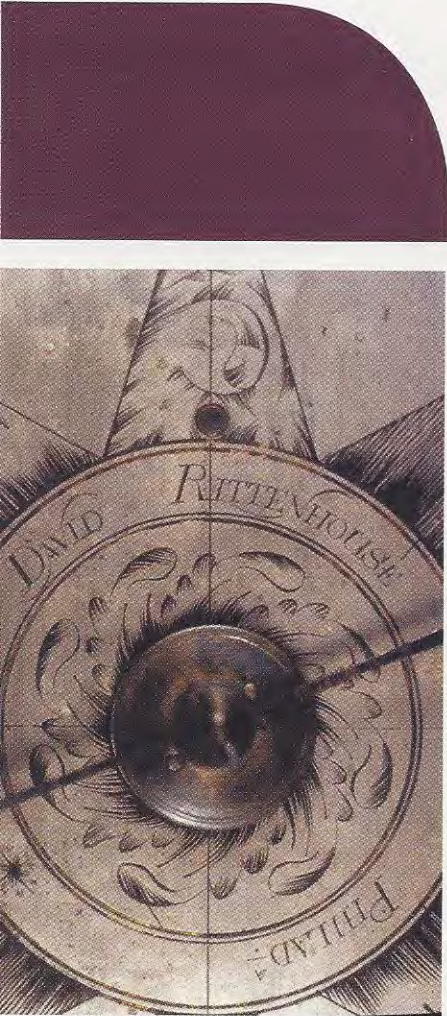
Figure 2

(Figure 2). David, the elder, was the accomplished astronomer who, in documenting the Transit of Venus in 1769, established his reputation as a world-class astronomer, mathematician, clock maker, and instrument maker. The fact that this instrument was indeed the work of the master, David Rittenhouse, made the cut-off arms even more of a travesty. After the shock wore off and I began the initial study of this seemingly defaced masterpiece, I was able to identify characteristics that made it clear this was no ordinary surveyor's compass. Underneath the compass box there was a large, full-circle ring gear (Figure 3) as well as a second gear-drive assembly on the socket that would permit the entire unit to be precisely rotated up to 45 degrees (Figure 4). I was quite relieved to find, after closer inspection, that the apparent cut-off ends of the main horizontal arms were in fact remnants of opposing verniers that were originally pinned to the ends of the fiducial North/South arms of the compass (Figure 5). The remnants of these arms carried the partial engraving of the vernier scale that made it obvious this was no typical surveyor's compass (although even an ordinary surveyor's compass by David Rittenhouse, the elder, is quite rare; at this date only seven examples have been recorded). It became clear this was in fact the central compass and arms of a theodolite and is the only one known to have been built by this esteemed maker. As I sat there, astonished at the historical importance of exactly what it was that I

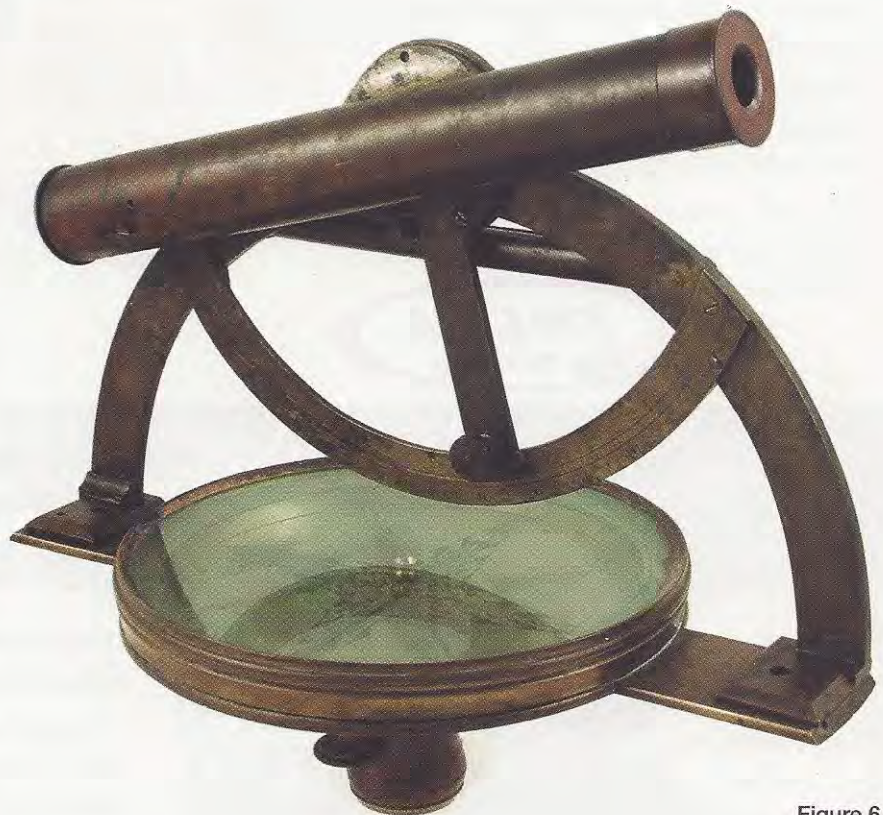
Figure 6

expecting to be any more impressed than I already was. To my amazement the owner reappeared with a small telescope mounted on a semi-circular vertical arc, with a scale obviously engraved by the hand of David Rittenhouse. This telescope and vertical arc assembly fit precisely into pinned holes in the North/South arms of the compass. (Figure 6) Not only did I have in my hands the only gear-driven theodolite by the

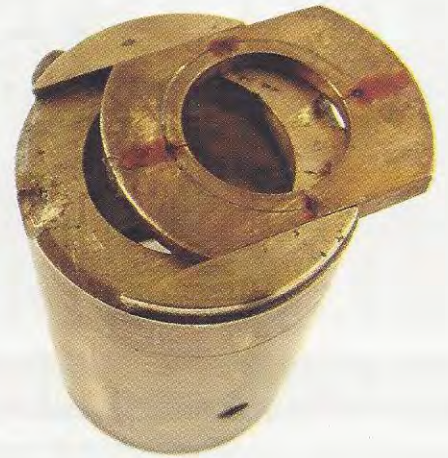
Figure 9

was non-erecting and upon disassembly revealed the provision for internal, adjustable cross hairs (Figure 9).
